ENVIRONMENTAL STEWARDSHIP PLAN

**Beth-El Temple Center
Belmont, Massachusetts**

September, 2003

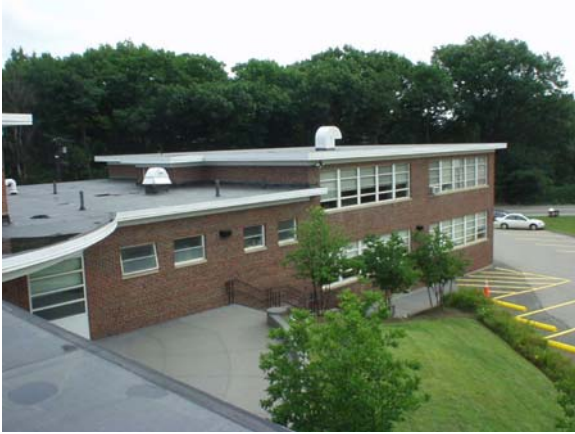
#4 — The building has rubber membrane roofs.

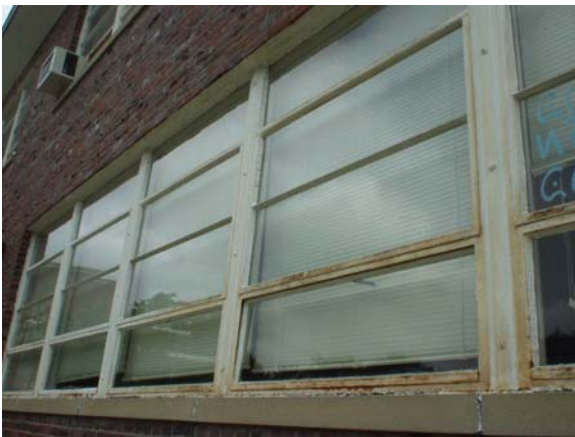
The building *walls* are brick. There are several *window* types, including new thermopane in the preschool space, metal frame single pane in most spaces and stained glass in the sanctuary. The windows do not have storm windows. They were installed at original construction. The *roof* is rubber membrane, installed sometime in the past 10 years. There is insulation in the full attic

#5 — The original metal frame single pane windows are nearing end of useful life. They present energy efficiency challenges, especially when window ACs are added.

It is recommended that metal frame single pane windows be replaced with contemporary standard high-efficiency Lo-E thermopane windows, for reasons of energy efficiency and occupant comfort. Finally it is recommended that the roofs have photovoltaic (PV) panels installed as a means of direct, non-polluting electricity generation.

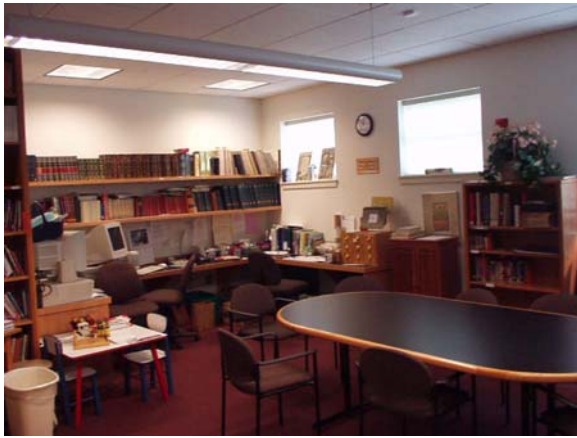
#10 — The library is one of several rooms with fan coil units for space conditioning.

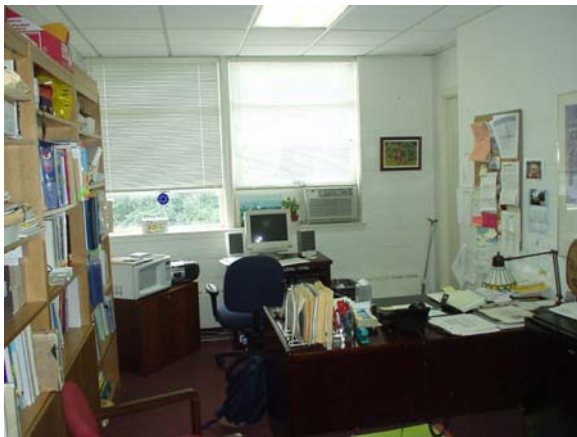
#11 — The offices and classrooms have baseboard hydronic heating.

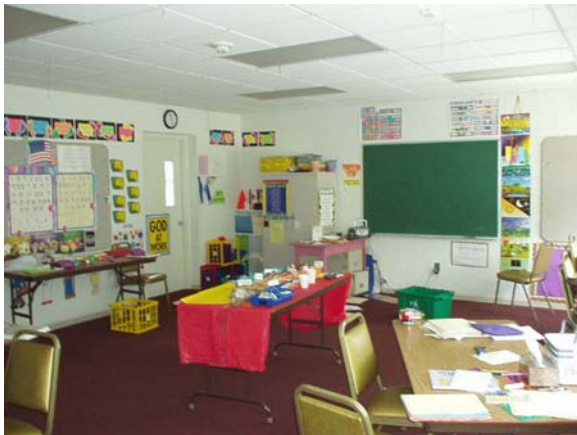
#12 — Classroom wing has suspended tile ceilings with florescent lighting.

Upgrades in lighting are possible, with use of both efficient lamping (CFLs) and fixtures sensible. Replace equipment with Energy Star rated; with refrigerators have the quickest payback.

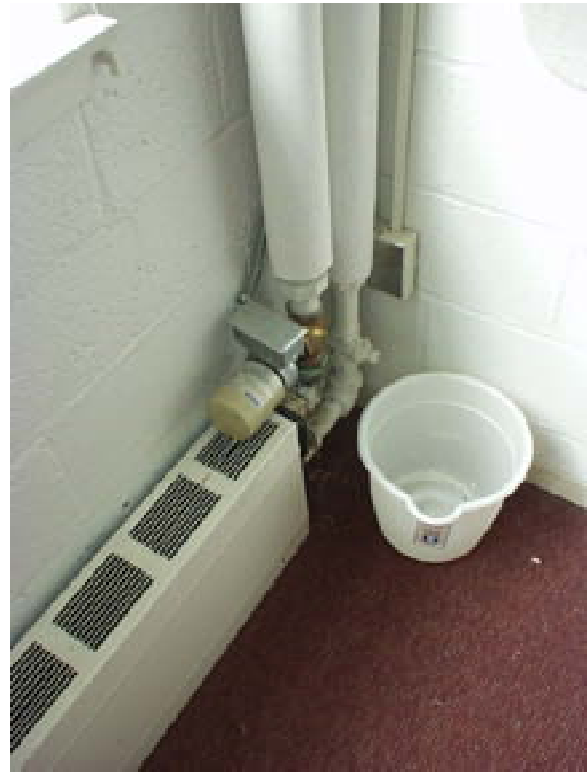
#13 — Detail of radiator and controls in classroom wing.

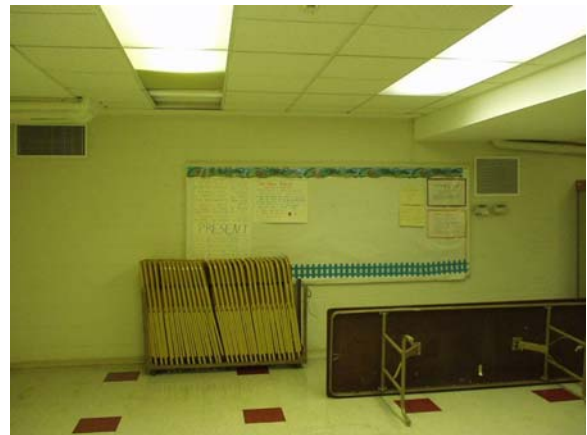
#14 — The meeting room in the basement has space conditioning via a fan coil unit (FCU) located in the space behind this wall, with conditioned air delivered via the wall diffuser. It also has a cabinet FCU, on the opposite wall.

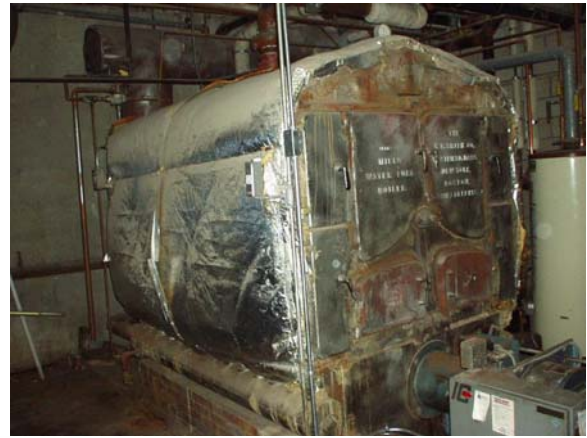
Heat is generated for the entire facility by an *oil-fired hydronic boiler*. The boiler, manufactured by H. B. Smith, was installed in 1954, when the building was constructed. It is estimated at 1,500,000± btu. Given age and condition, it has an estimated efficiency of below 70%. The heating system has pneumatic *controls*, installed in 1954, with in-room thermostats and zone valves. Heating *distribution* is by several means. Duct work serves the sanctuary and social hall, with conditioned air (heated or cooled) distributed by fan coil units (FCUs) located in the attic. There is also a FCU in the basement, serving the meeting room. There are cabinet FCUs in the lounge, administrative office, rabbi's office, library, bride's room off the social hall, and the cantor's office. These spaces are essentially the "core" area. The classroom area (which includes two other offices) has baseboard hydronic radiation with zone valves. There are *circulating pumps* of various vintages.

#17 — Oil-fired boiler dates to construction of the building, in the 1950s. It is beyond its useful life.

The congregation is currently considering heating/cooling system replacement for the sanctuary and social hall. Several actions are appropriate, all discussed here though involving cooling also. First, it is proposed to install **package roof top units** (gas heat/electric air conditioning, with an economizer for "shoulder season" conditioning) to serve the sanctuary and social hall. The use of "RTUs" is appropriate given the volume and timing of use of these spaces. The most energy

efficient equipment available (highest SEER rating) should be installed, as reduced costs and environmentally-responsible operation objectives will be met, with good paybacks in both regards. The equipment needs to be installed to minimize vibration. The equipment sizing and associated distribution need to be carefully calculated by an engineer. Second, a new **gas-fired condensing mode hydronic boiler** for generation of heat for the remainder of the building and for generation of domestic hot water (via an in-direct fired tank, discussed below) is recommended. As with the RTUs, the load requirements and therefore sizing of the new boiler need to be calculated by an engineer. Use of the condensing mode type provides efficiencies at the 93% range. Use of high efficiency equipment will also increase the level of financial incentives offered by KeySpan, the provider of natural gas. Third, install a **digital control** system for the heating and cooling systems. The method and equipment for control needs to be inventoried, and good maintenance obtained. (See the maintenance section, below.)

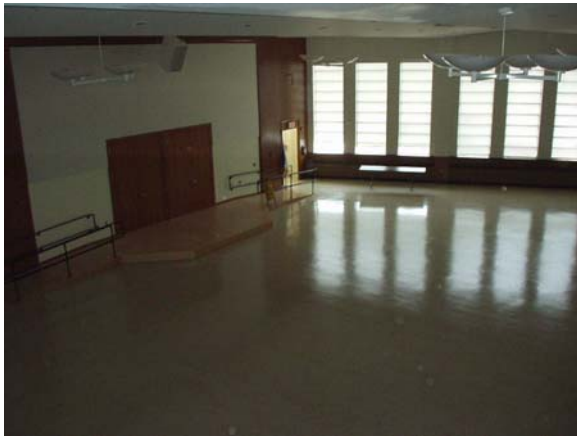
#15 — Social hall connects to sanctuary, with a folding door able to separate the two spaces. This space is also conditioned by attic mounted fan coil units.

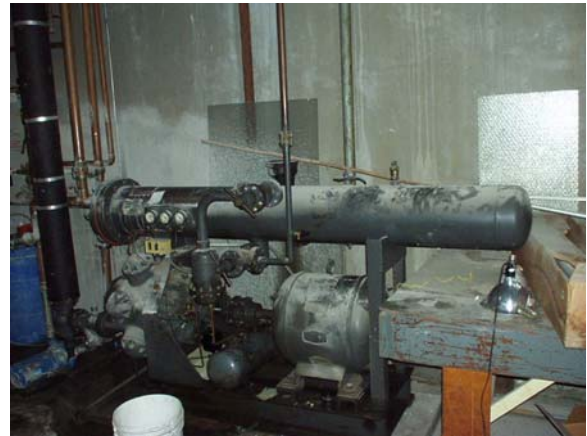
Cooling is provided to the sanctuary and social hall spaces via FCUs, with a cooling tower and chiller dating to original construction. Air conditioning for the core spaces (including the kitchen) was added in 1999, with roof-top condensing units at 5 and 15 tons. The preschool room and some offices have in-space through-window ACs, of various ages.

#18 — Chiller is basement also dates to the construction of the building, and is beyond its useful life.

The RTUs for the sanctuary and social hall will provide electric air conditioning. Use of the *economizer* function in “shoulder seasons” (spring and fall, when temperatures vary and both heating and cooling is desired) is an effective means of meeting space conditioning needs at lower cost. As with the heating element, the cooling portion of the RTUs needs to be of the highest energy efficiency (SEER rating). Evaluation of the cooling portion of the core spaces (added in 1999) should be part of the initial work scope developed using the MIP&L maintenance contract template, discussed later. Use the highest SEER Energy Star equipment when replacing in-space ACs.

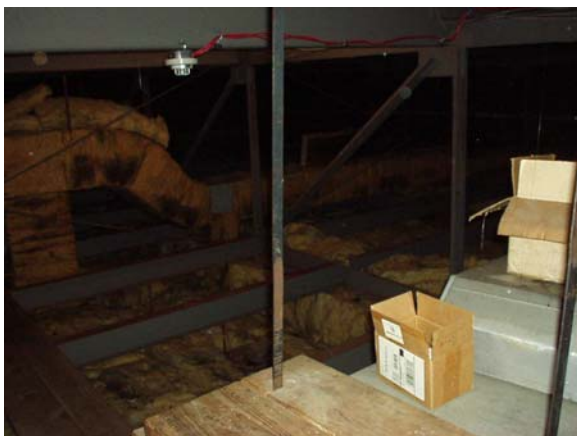
#16 — Attic space over sanctuary, with batt insulation above ceiling, also wrapping ducts.

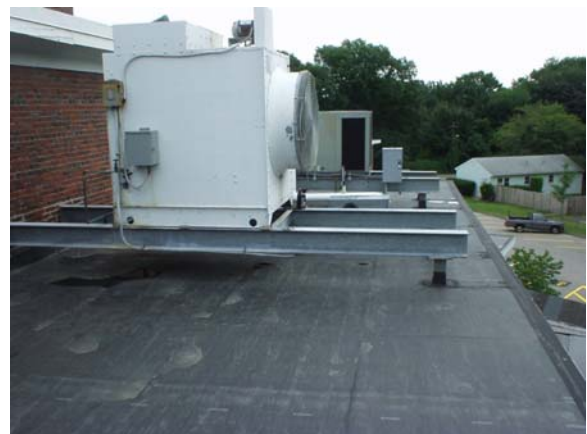
#19 — The roof over the rear of the social hall is the location of the cooling tower (foreground) and one of the newer condensers. A new condenser was installed at the same time, serving the kitchen.

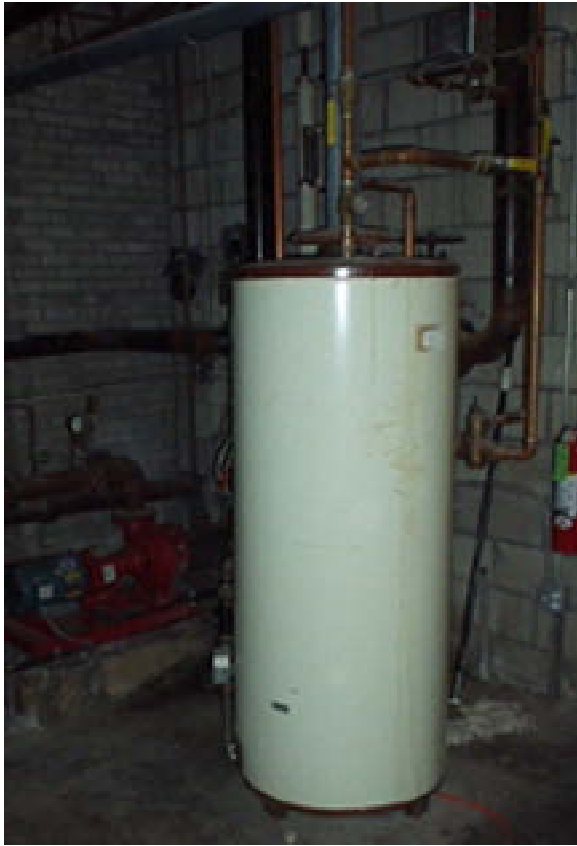
Domestic hot water (DHW) is generated by a 100-gallon *gas-fired* tank, located in the boiler room. This equipment was manufactured by A. O. Smith, and installed in 1994.

#20 — Domestic hot water tank is gas-fired. Note circulating pumps at left rear. Some newer circulating pumps have been installed.

It is recommended that an in-direct fired stainless steel DHW tank be installed concurrent with the new boiler. This will both save energy and have an extended life (20+ years) as compared to replacement of existing equipment in-kind.

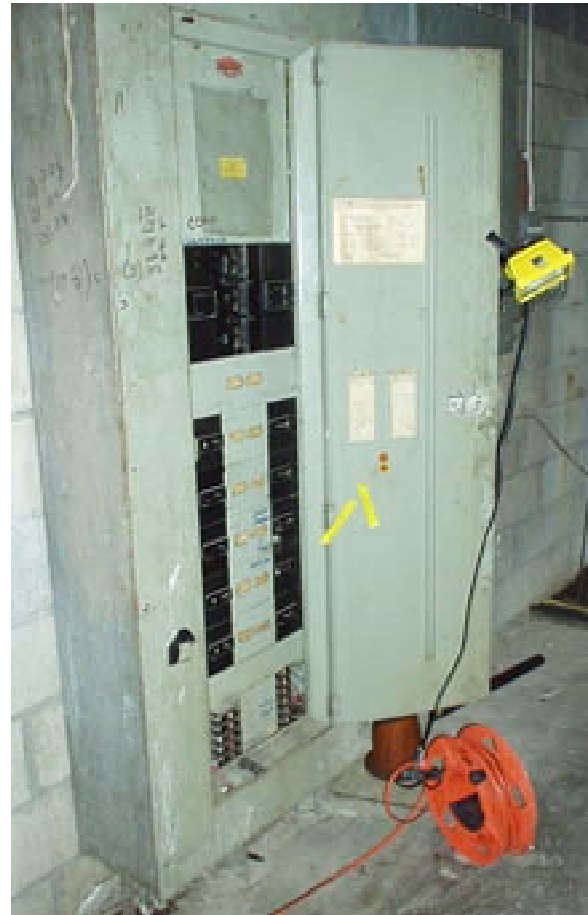
Electric *service* is provided to the facility via a main service duct that enters the building in the basement. It was installed in 1954, with some subsequent modifications and additions in service, sub-panels and wiring. Service is rated at 400 amps. The *lighting* varies by room, with

#22 — Electric service dates to building construction. Upgrades for new HVAC and contemporary uses of electricity likely.

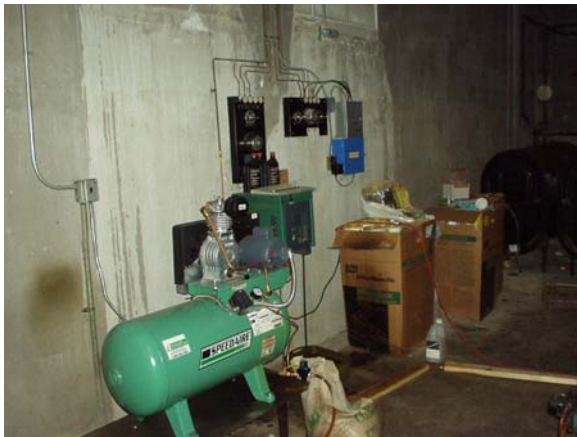
#21 — Original building controls are pneumatic. Replace with digital.

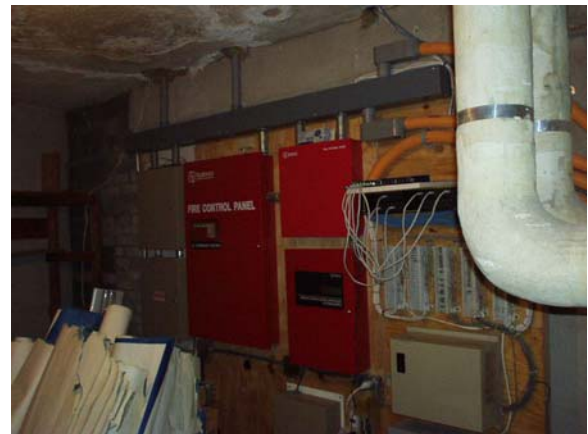
#23 — Fire controls are in basement. Monitor regularly to ensure proper operation.
