## Charles Street AME Church, Roxbury, MA

### Taking The First Step Of The *Caring for God's Creation* Faith Journey

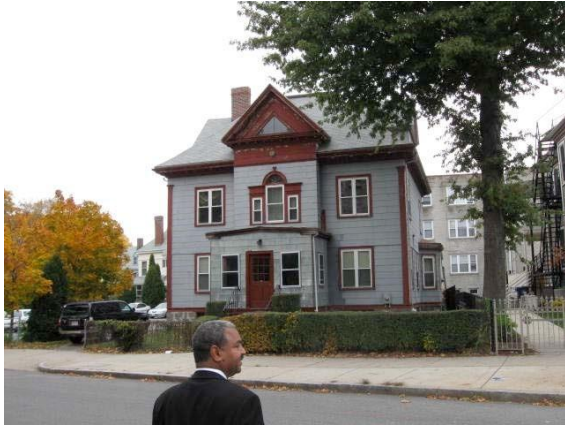
#1 — 5 Elm Hill Avenue is a 3 story + basement building, providing office, meeting and residential space.

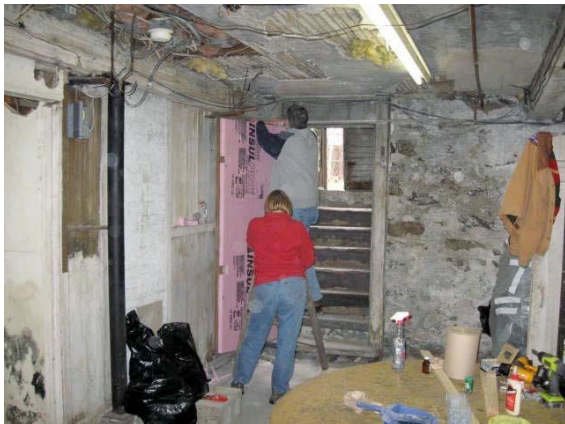
#2 — Wood hollow-core door with 1.5” rigid insulation added. “Great Stuff” foam insulation used to seal around frame and cracks in shed over stairs down. Basement ceiling had blown insulation some years back. The objective with

insulation and caulking is to “fill every hole” so that cold stays outside in winter.

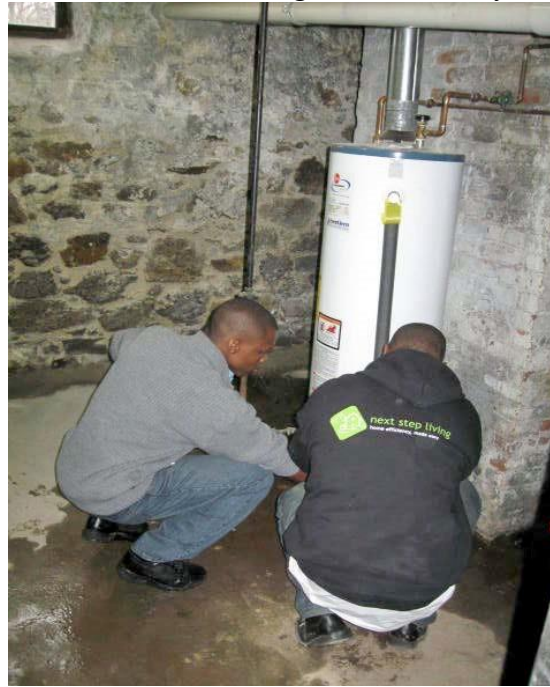
#3 — Gas-fired domestic hot water (“DHW”) tank having temperature setting lowered from HIGH to LOW. DHW was tested at the kitchen sink, and measured over 150°, which is scalding. Should be at 120°, or even less if being used for children such as at a Day Care Center. The temperature setting is an easily-understood dial, and can be adjusted by just about anybody. Setting lower – and installing low-flow aerators on faucets and low-flow showerheads — means less water and less DHW, so use reduce then cost\$ reduced. Adding an insulation blanket to the DHW tank can also

even for newer DHW tanks which are better insulated than old.

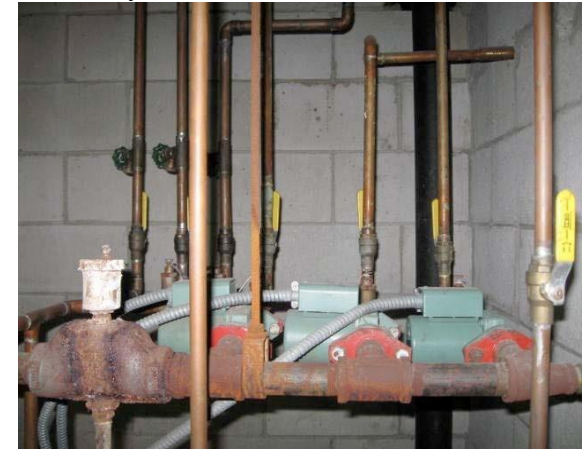
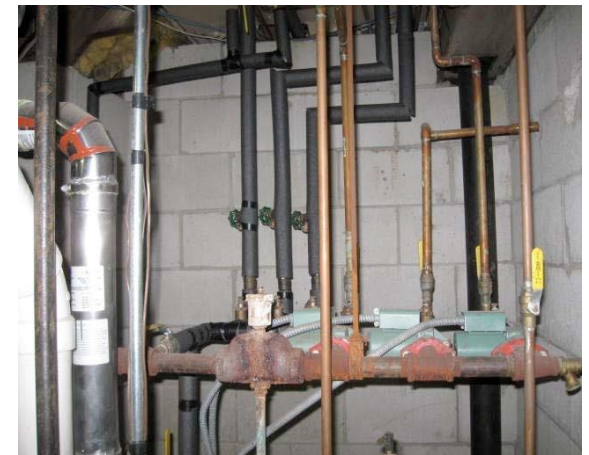
#4— Pipes over boiler before (above) and after (below). Insulate heating and DHW pipes in non-occupied spaces. Get heat and domestic hot water where the people are!

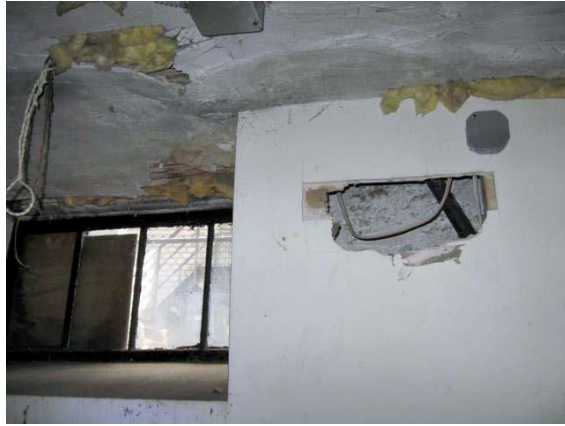
#5— All basement windows now have interior “storm” window installed. This significantly improves thermal performance is this large “hole” in the wall. The cracks and voids around the windows (and especially in the ceiling above) filled by spraying “Great Stuff” foam and adding fiberglass insulation.

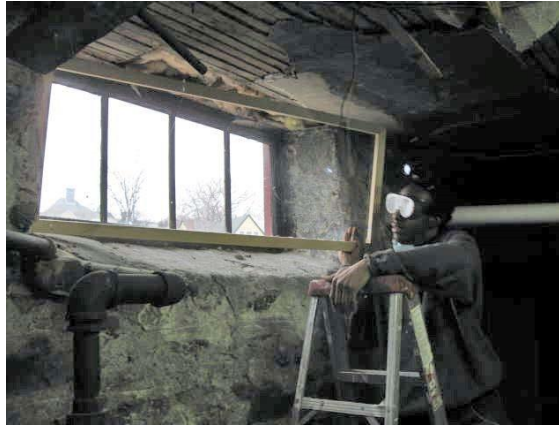
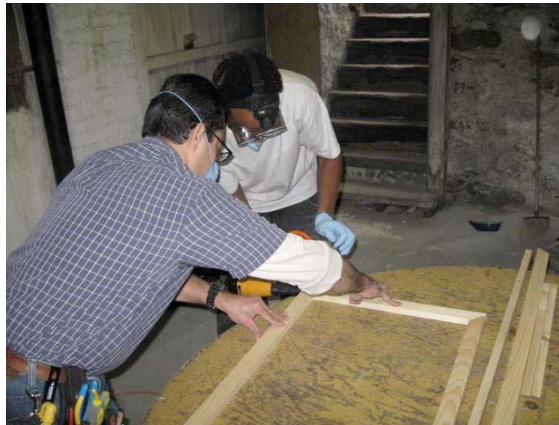
#6 —Interior “storm” windows are easy to make, and are light weight. Wood frame (above) is nailed together at corners. Plexiglas is cut to size at supplier. Measure carefully! It has blue wrap to keep saw dust and scratches off. Plexiglas is adhered to wood by glue and then screwed to frame. Weather stripping is then

added around edge to create a good seal between this new storm window and existing window frame.

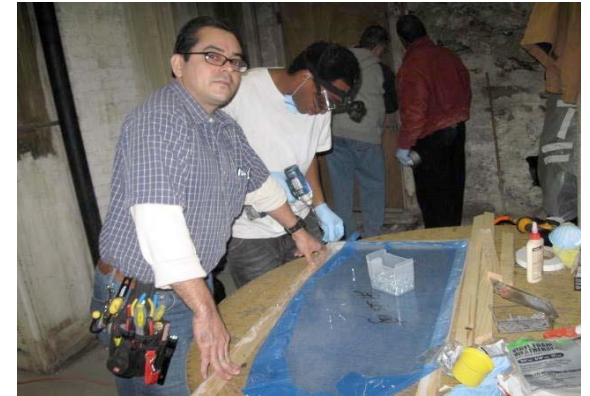
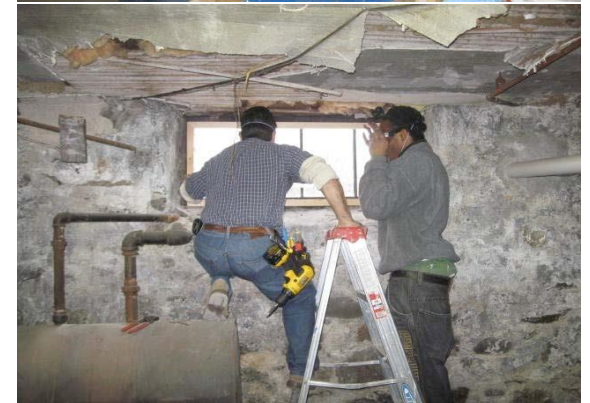
#7 — After pre-drilling holes for screws, attach window in existing window frame. Some interior “storm” windows (such as these) can stay year round. In occupied spaces where windows will be opened for circulate, remove in late-Spring and install

again in mid-Fall. In occupied spaces  
“storms” should be painted to match  
window frame.

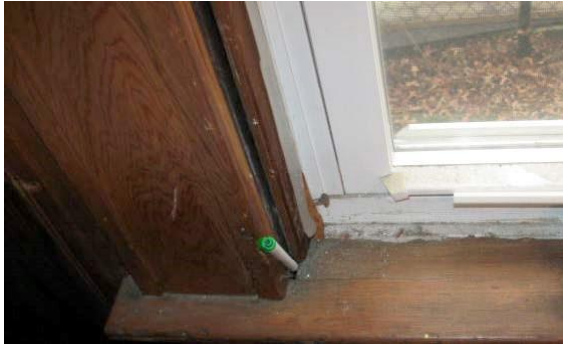
#8 — And more holes to fill, in upstairs  
rooms! If a pen can fit into one hole and  
there is a void all around, imagine how  
large the total “hole-in-the-wall” is!
